Miscellaneous Paper CHL-98-6  
August 1998

# Toussaint River Unexploded Ordnance (UXO) Demonstration Dredging Project

*by Timothy L. Welp, James E. Clausner, WES  
Raymond L. Pilon, Buffalo District*

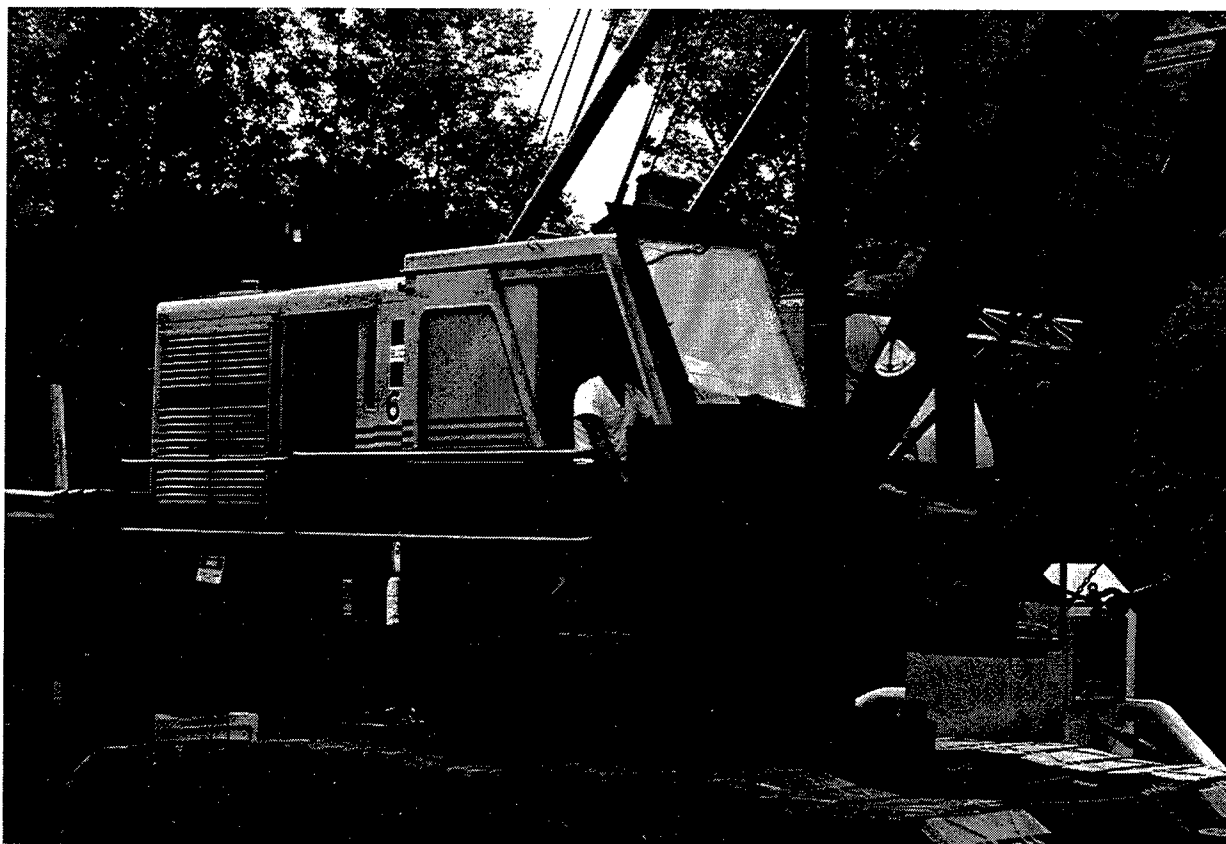
Engineering controls to counter health hazards due to potential UXO detonation consisted of enclosing the crane operator's booth with a 6.4-mm- (0.25-in.-) thick steel plate protection barrier with a viewport consisting of 64-mm- (2.5-in.-) thick polycarbonate laminate. This viewport provided the equivalent resistance of

6.4- mm- (0.25- in.-) thick mild steel plate (Figure 2). The 24-m (80-ft) crane was required because it allowed a minimum separation distance of 16 m (52 ft) between the operator and the clamshell bucket (also a protective barrier). The Huntsville Division designed the appropriate safeguards, including the protective barrier and the separation distance, using the computer program CONWEP to analyze effects of a potential detonation (i.e., equivalent weight of TNT, peak overpressure, fragmentation, etc.). This analysis was based on a 106-mm anti-tank round, the maximum-sized UXO perceived as a threat.

Figure 2. Crane operator's protective barrier

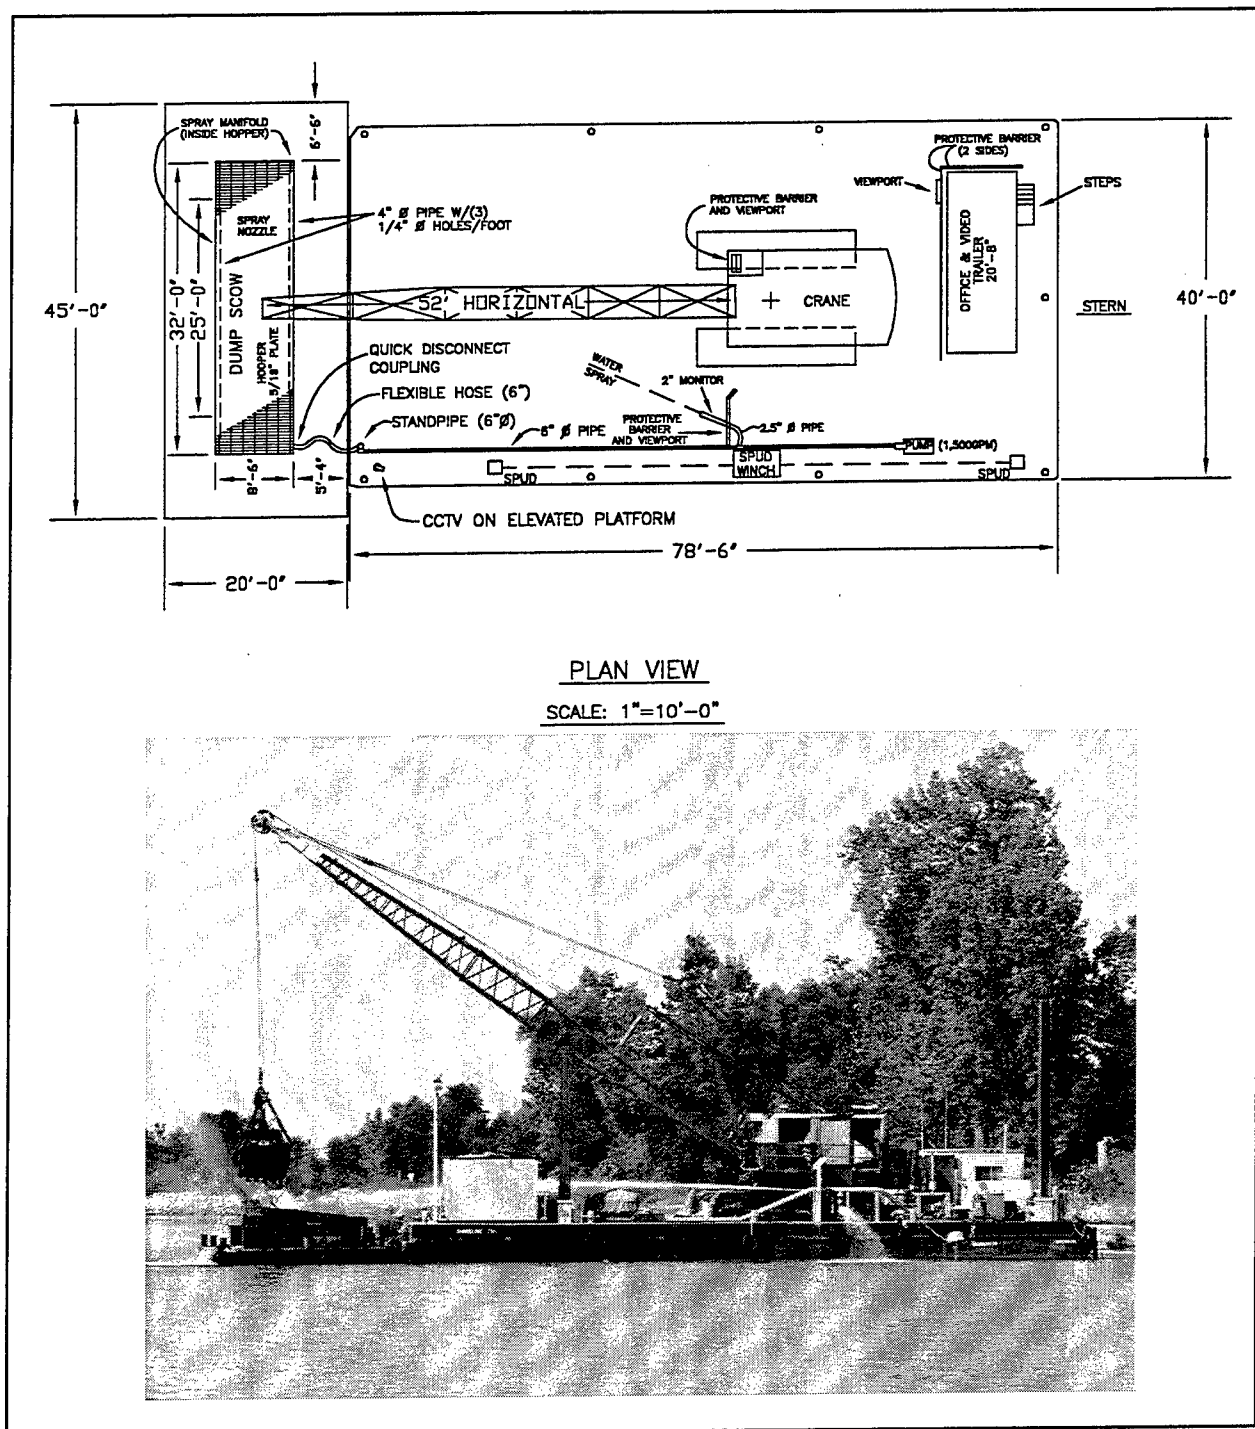
The clamshell excavated medium-sized sand (average  $d_{50}$  of 1.2 mm) from the navigation channel and dumped onto the scow secured "alongside" as shown in Figure 3. The project used two 65-m<sup>3</sup> (85-yd<sup>3</sup>) capacity bottom-dump scows 14 m by 6 m by 2 m (45 ft by 20 ft by 6 ft) to transport dredged material to the disposal site. These scows were pushed with the work boat *Falcon*, an 11-m by 4-m by 0.8-m (36-ft by 12-ft by 2-1/2-ft) motor vessel equipped with pusher knees and propelled by a 350-hp diesel engine. The shallow drafts of the *Shoreline* 785, *Falcon*, and both scows allowed dredging to be conducted in water depths as shallow as 1.2 m (4 ft).

Figure 3. Deck layout (Courtesy of Shoreline Contractors, Inc.) and photograph of UXO dredging system

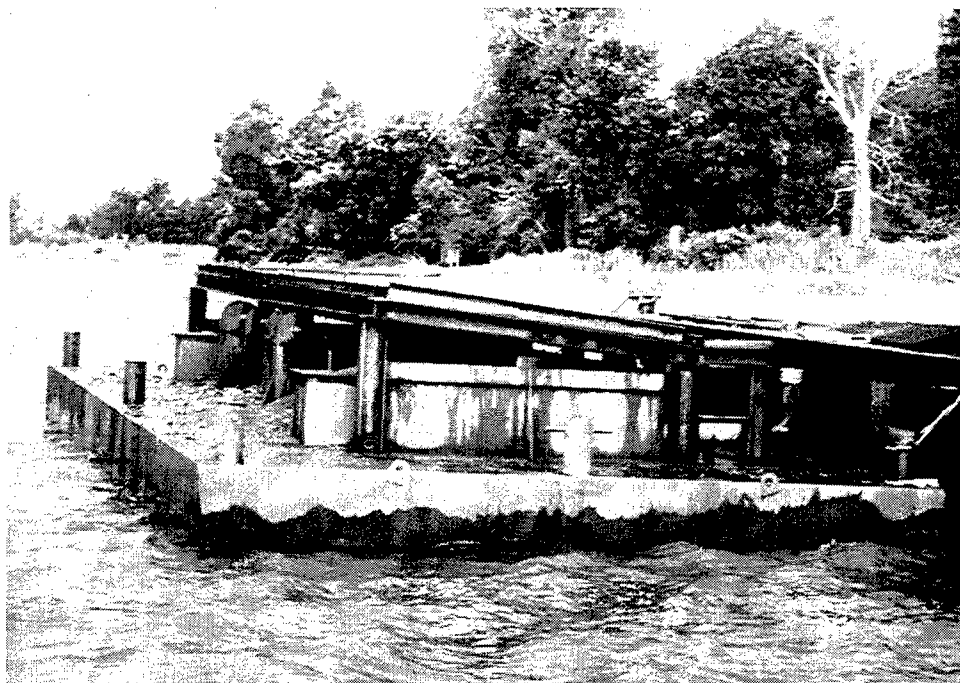
The separation screen was mounted over each scow on an I-beam support structure welded to the deck and inclined approximately 10 deg from the horizontal plane (Figure 4). In the event of a detonation, the screens were

Figure 4. Scow and separation screen

designed and constructed to allow damaged sections to be replaced or repaired. Each screen's 25-m<sup>2</sup> (272- ft<sup>2</sup>) total surface area was divided into two equal sections, 5 m by 2.6 m (16 ft by 8-1/2 ft) each that were removable to facilitate repair of detonation-induced damage and also to clean debris by lifting one side with the crane. The contract specifications required that the maximum screen opening dimensions be 19 mm (0.75 in.) in one direction and 127 mm (5 in.) in the other direction. These dimensions were based upon the design objective of retaining 20-mm projectiles. The screens used by the contractor initially consisted of coal-tar epoxy-coated bar grating with 19-mm by 114-mm (0.75-in. by 4.5-in.) openings that were 19 mm (0.75 in.) deep, but these dimensions were later modified as the project progressed (these changes are discussed later in the paper). Contract specifications required that the screen be constructed such that the maximum allowable opening dimensions were not to be exceeded even when it (the screen) was fully loaded with a design load of 4.6 m<sup>3</sup> (6 yd<sup>3</sup>) of dredged material (approximately 8 tonnes (9 short tons)).

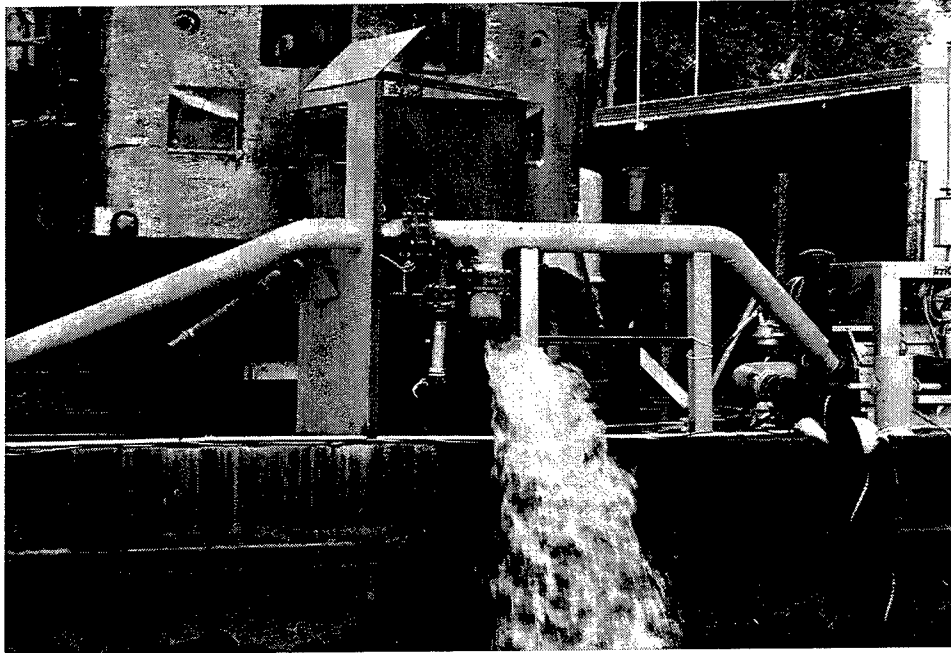
As the clamshell operator dumped dredged material onto the screen, a jet of water was manually directed into the dredged material from the water cannon station. This water jet facilitated screen throughput by fluidizing sediment and disintegrating the more cohesive clumps. The spraying system used a 100-mm (4-in.) (discharge) fire pump rated for 95 L/sec (1,500 gpm) at 24 bars (350 psi). This pump's discharge was coupled to a 152-mm (6-in.) expansion pipe system with a three-valve flow control system that regulated flow to the water cannon, excess overboard discharge, and the scow's internal spray system (Figure 5). The

Figure 5. Fluidization valve-control system

water cannon control valve regulated flow through a 64-mm (2.5-in.) flexible hose that was connected to a fire-fighting nozzle with a 64-mm- to 25-mm- (2.5-in.- to 1-in.-) diam reducer configuration (Figure 5). The water cannon operator was protected from potential UXO detonation by a protective barrier with the same construction materials and thicknesses as the crane operator's enclosure previously described. The nozzle was set in a gimballed mount located immediately below the viewing port and provided with a 6.4-mm- (0.25 in.-) thick steel rectangular protective barrier to cover the gimbal opening (Figure 6). This mount, comprised of two concentric swivels, provided the water cannon operator with two degrees of freedom to direct the water jet to any location on the entire screen surface.

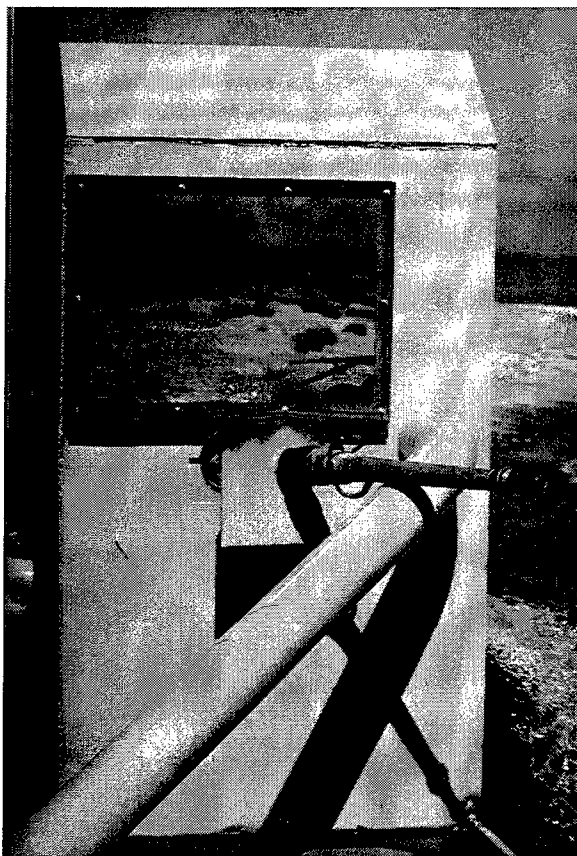
Figure 6. Water cannon operator's station

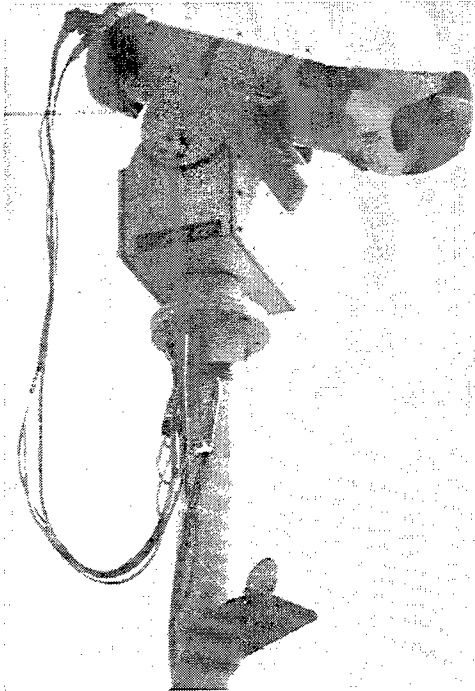
an explosion-proof and waterproof enclosure equipped with remote-controlled pan and tilt capabilities (Figure 7).

The screening process was visually monitored by EOD personnel in the observation trailer (OBST). Human Factors Applications Incorporated (HFA) of Holicong, Pennsylvania, provided EOD support during the demonstration in the form of equipment and personnel to locate, identify, recover, transport, and dispose of ordnance encountered. The OBST was equipped with a steel protective barrier and polycarbonate viewport on the side facing the screen (Figure 3). During the actual dredging, all personnel except the water cannon and crane operators were stationed inside the OBST. A closed-circuit television (CCTV) high-resolution camera lens was mounted on a 4.6-m (15-ft) mast near the screening area. The camera's 10X f1.8 motorized zoom lens with auto iris was housed in

Figure 7. 10X zoom lens with remote-controlled pan and tilt

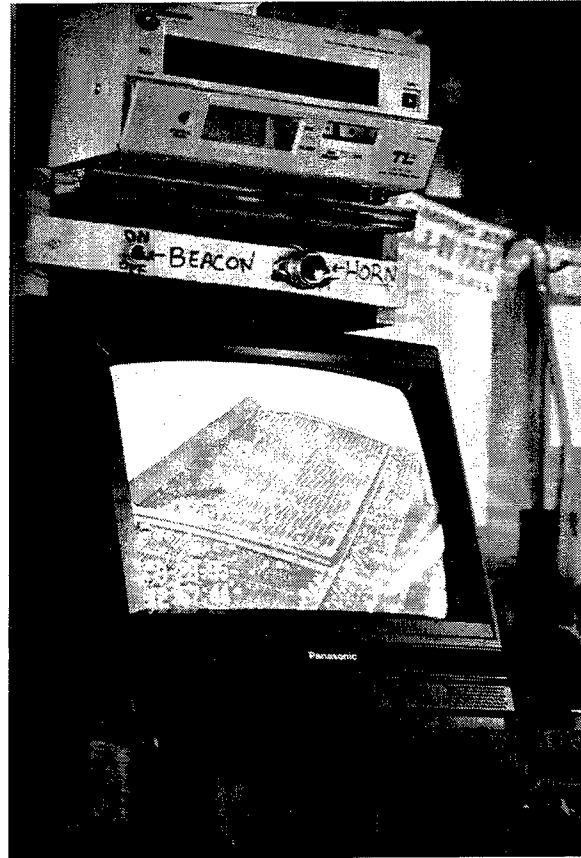
An operator in the OBST controlled the camera's zoom, pan, and tilt functions. A color video monitor and time-lapse recorder were connected to the camera via a fiber-optic link to provide color-corrected professional-quality images (Figure 8). The CCTV field of view provided coverage of the entire screen surface. As a surveillance system backup, one EOD person monitored the screening process by looking out the view port with binoculars.

Figure 8. CCTV control station inside the OBST (lens zoomed out)

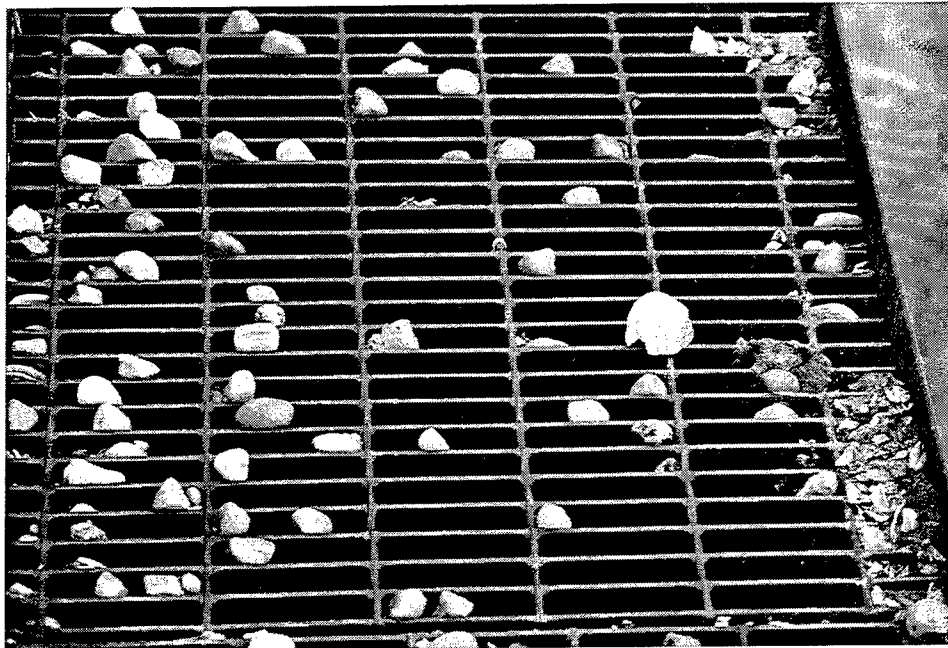
Soon after dredging commenced, it became obvious that, even with the combination of water cannon jet and scow internal spray acting on the sediment, the screen's 19-mm by 114-mm (0.75-in. by 4.5-in.) rectangular openings were becoming excessively clogged (blinded off) by clamshells and rounded coarse gravel (Figure 9). Cleaning the debris that were wedged between the grates proved to be a very time-consuming, labor-intensive job. As the clamshell excavated deeper into the sediment, unexpected amounts of clay (brown-gray with medium high plasticity) and peat were encountered. This clay further decreased production due to the water spraying systems' inability to disintegrate the more cohesive clumps.

Figure 9. Blinded-off bar grate separation screens

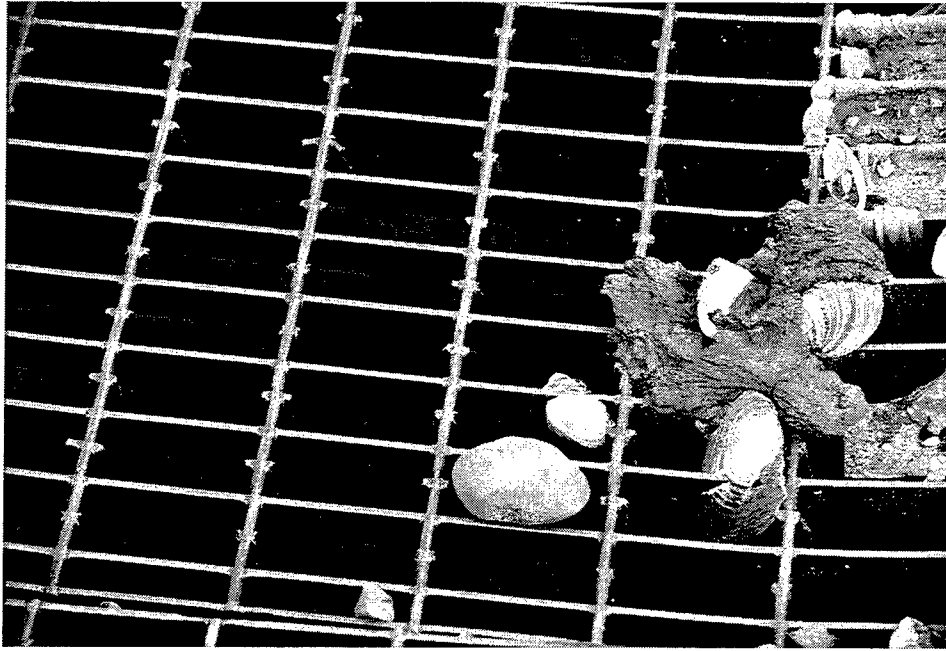
These increased amounts and types of debris remaining on the screen surface after the scow was full, would, in turn, increase the time required by EOD personnel to safely inspect and clear. With approval from the Huntsville Division, it was decided to expand the screen opening area by cutting out every other lateral grate bar. Removal of these laterals increased the rectangular dimensions to 38 mm by 114 mm (1.5 in. by 4.5 in.) (Figure 10). This modification dramatically increased screen throughput by allowing more clamshells and coarse gravel to pass through (less blinding), but, when encountered, the more cohesive clumps of clay and peat still remained troublesome.

Figure 10. Modified bar grate screens

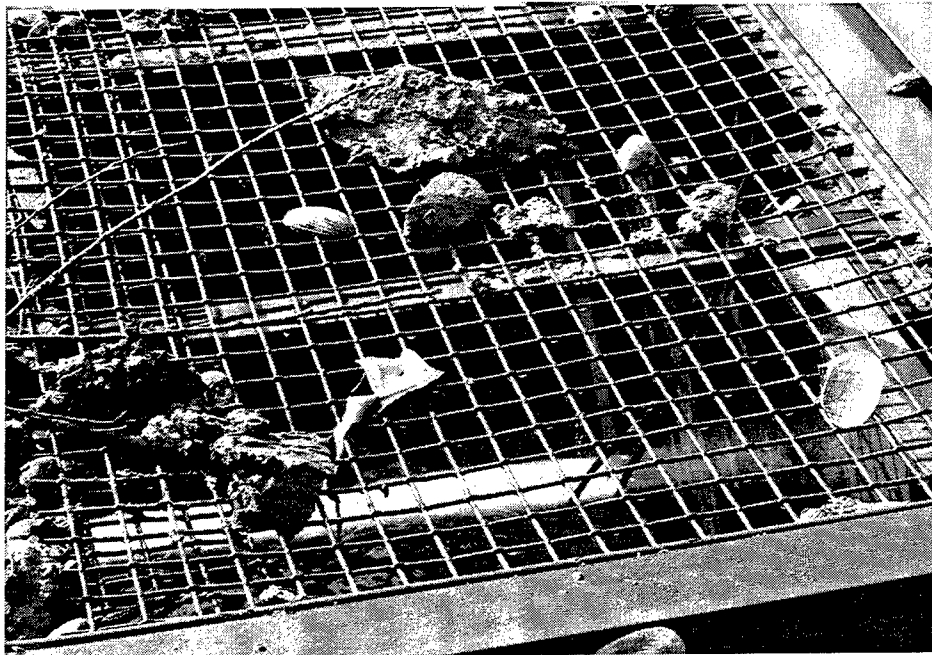
"Space cloth" made from 6.4-mm- (0.25-in.-) diam round stock with 50-mm by 50-mm (2-in. by 2-in.) square openings was used to replace the more damaged grate sections (Figure 11), but the use of this type of screen required welding

Figure 11. Space cloth separation screen

additional I-beam cross members into the screen frame for support. After this modification, no significant difference in throughput rates was noticed for the space cloth as compared to the modified bar grate.

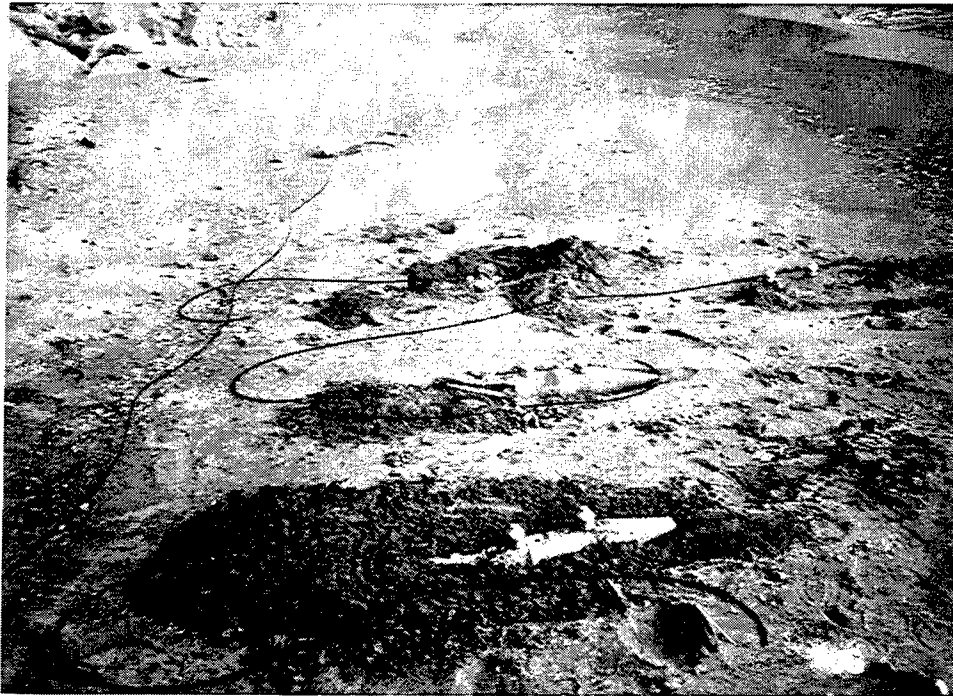
If the target was ordnance, as it was after the 8th day of dredging (a smoke grenade and 106-mm projectile), a 5-m (16-ft) diesel-powered (reduced fire hazard) boat piloted by another EOD specialist would be brought up alongside and the ordnance would be sand-bagged, and transported to shore. At the disposal site, the ordnance was laid in a shallow pit and shaped charges were fastened to its casing (Figure 12). Detonation cord was used to initiate the shaped charges and the focused energy of the explosion breached the ordnance's casing. Only after a casing was breached could an item be conclusively classified as UXO or inert ordnance.

Figure 12. Ordnance prepared for disposal detonation

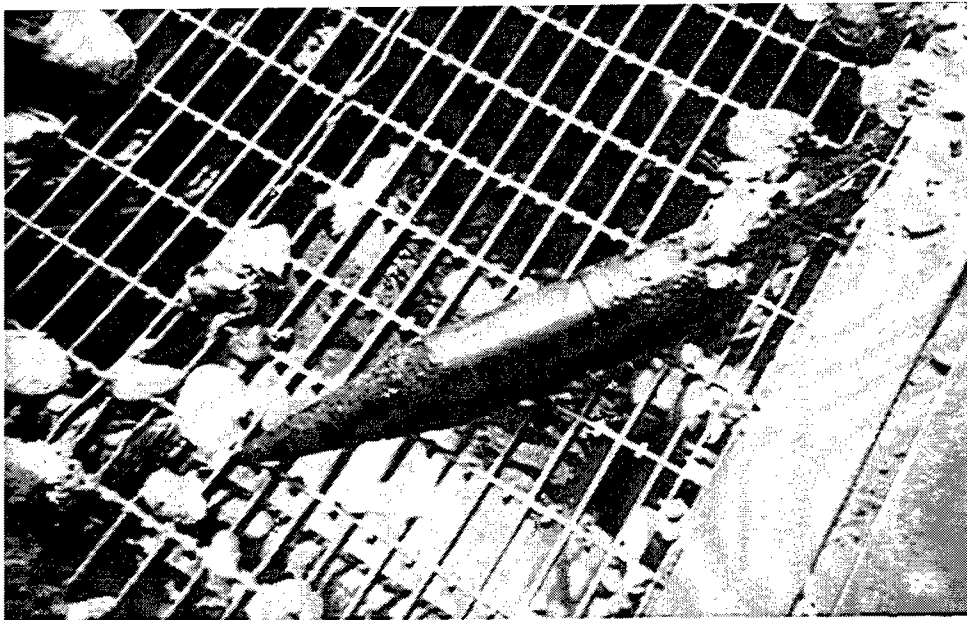
During the 79-work-day duration of the demonstration project, 14,757 m<sup>3</sup> (19,300 yd<sup>3</sup>) of material was removed from the authorized channel limits (as determined by hydrographic survey) during 72 actual days of dredging. The remaining 7 days were spent conducting various tasks such as altering screens, repairing the dredge plant, etc. A total of 37 pieces of ordnance were recovered from the separation screens and properly disposed of (resulting in 568 lb of scrap metal). From this total, 31 pieces were classified as inert ordnance, and the remaining 6 as UXO (HFA Inc. 1996). In Figure 13, a 106-mm projectile can be seen in the condition that it was recovered from the screen. Table 1 classifies the total amount of ordnance recovered during the demonstration and Figure 14 shows several different types of ordnance recovered during the demonstration (note condition of 60-mm mortar in lower right-hand corner after being breached by shaped charge).

Figure 13. 106-mm projectile on the separation screen

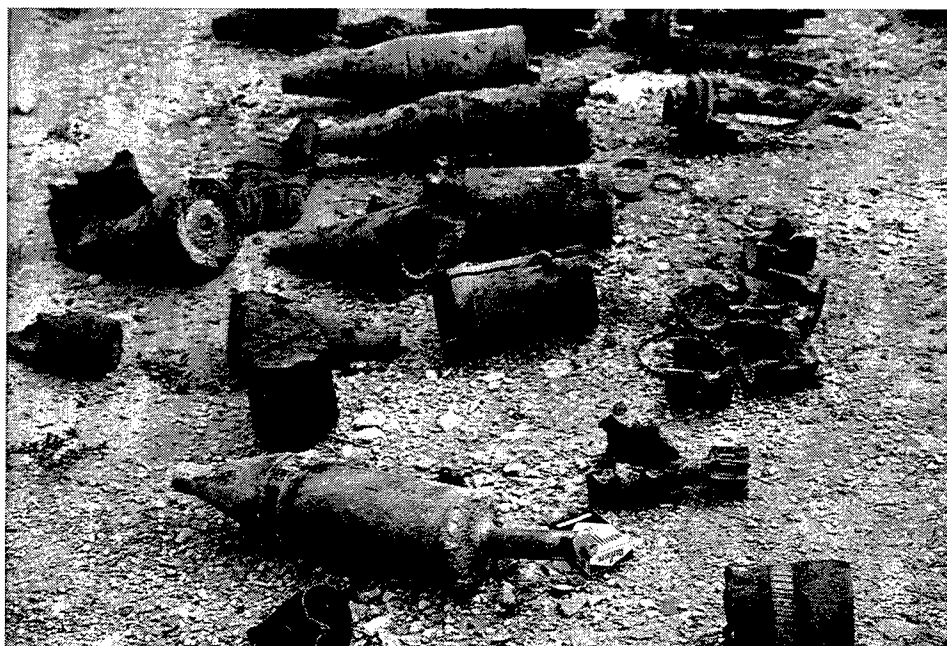
Figure 14. Several examples of recovered ordnance
